**Multi-Way Stop Warrant Analysis**  
Gosnold Street at Andover Street Intersection  
September 6, 2023

Petition:	Councilor Candy Mero-Carlson on behalf of Amelia O'Brian request installation of four-way stop signage at the intersection of Gosnold St. and Andover St.  # 8s CC April 26, 2022
Scheduled Committee Hearing:	September 20, 2023 Traffic & Parking Committee, Item 7c
Prepared by:	Scott W. Galbraith, PE, Senior Traffic Engineer

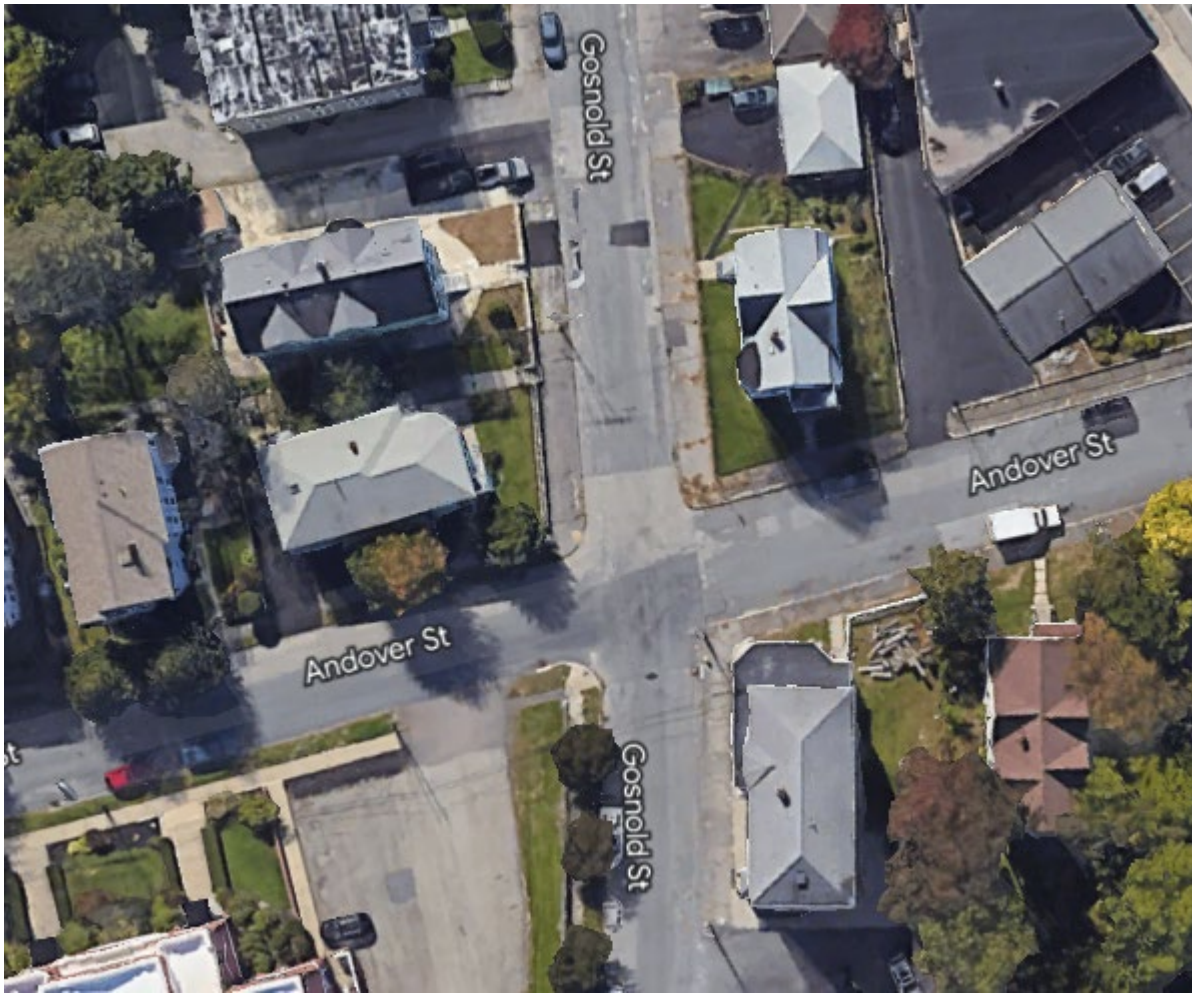
**Figure 1: Aerial view of Gosnold St-Andover St intersection.**

The intersection of Gosnold Street and Andover Street is a combination of roadway functional classes. Gosnold Street to the North and Andover Street to the East are Local roadways. Andover Street to the West and Gosnold Street to the South are Urban Collectors. Gosnold Street is the major street of this intersection, with stop control only provided for both Andover-Street approaches.

All approaches to the intersection accommodate two-way traffic with one travel lane in each direction. There are no apparent parking restrictions near the intersection, other than the statutory no-parking zones 20-feet from the intersection along all approaches and departures.

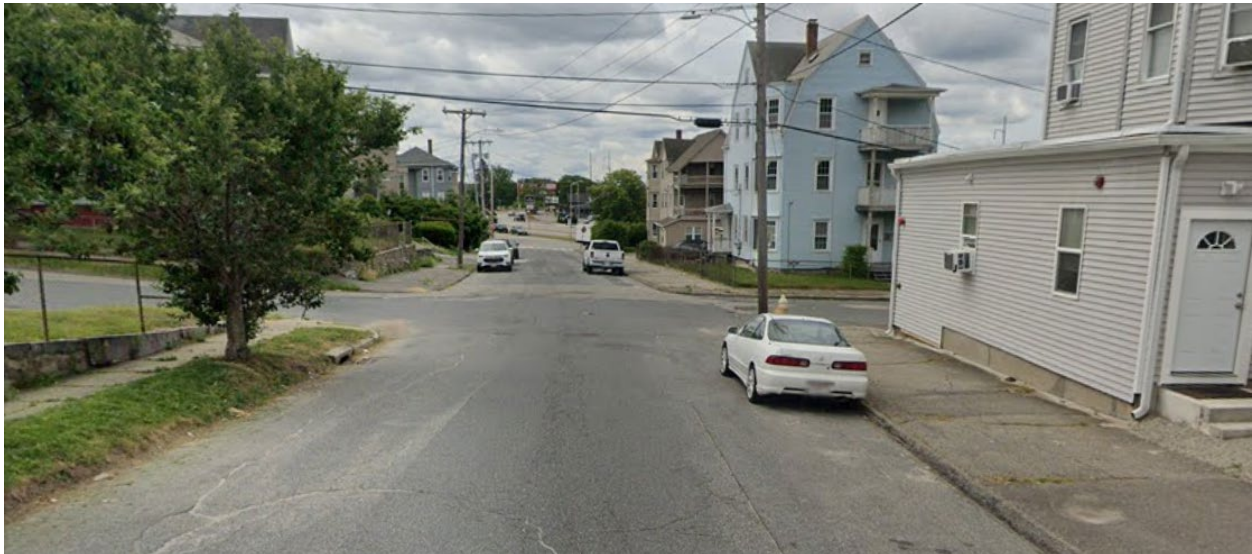
**Figure 2: View southbound on Gosnold St approaching Andover St (source: Google Street View)**

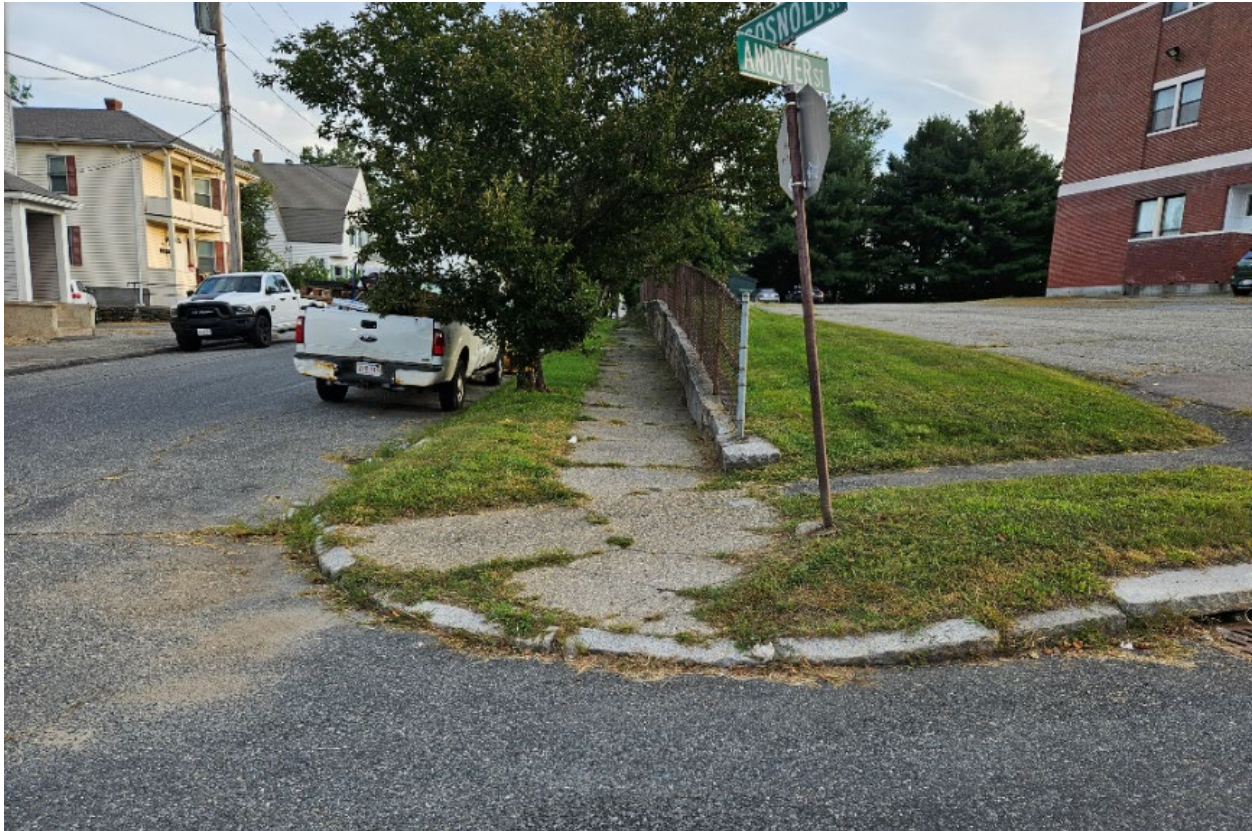
**Figure 3: View westbound on Andover Street looking north to Gosnold St (source: 9/5/2023 site visit)**

***Adequate sight lines are provided in all directions with one possible exception. Traffic traveling westbound on Andover Street can experience obscured sight distance looking north on Gosnold Street.***

*The Andover Street westbound approach to Gosnold Street may experience obscured sight distance when looking to the North. This is caused by a tree and larger vehicles parked along the eastern curb of Gosnold Street North of the intersection. We recommend trimming the lower branches of the tree and extending the statutory 20-foot no-parking zone another 20 feet from the intersection along this curb.*
