Multi-Way Stop Warrant Analysis

Barry Rd at Barry Road Ext and Toronita Ave Intersection

September 1, 2023

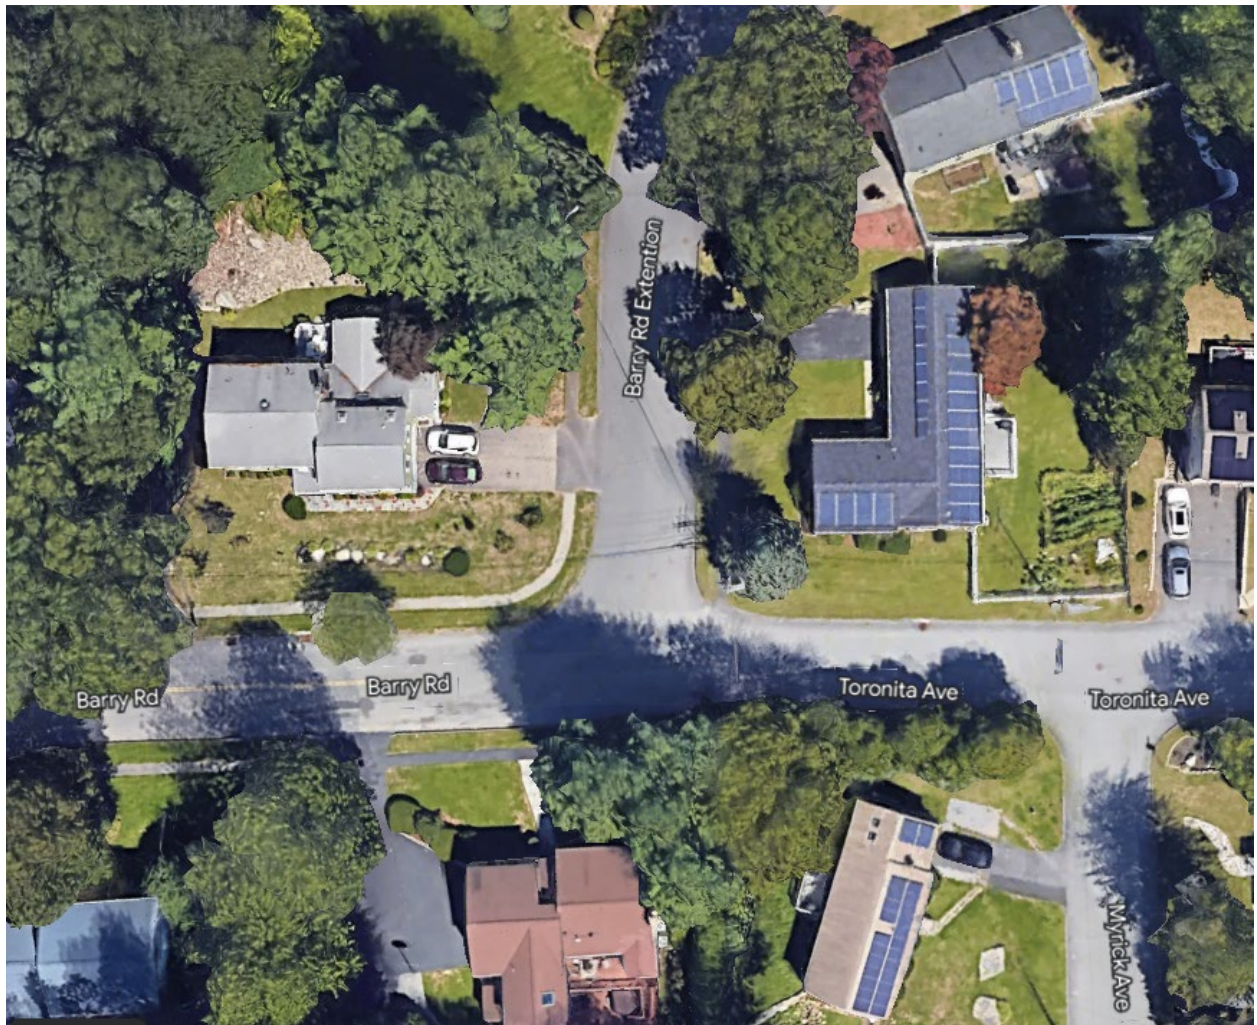
Figure 2: Aerial view of Barry Rd at Barry Rd Ext and Toronita Ave intersection. (Source: Google Earth)

The three-way intersection of Barry Road, Barry Road Extension, and Toronita Avenue is in a residential neighborhood with homes bordering all approaches to the intersection. A retirement community named The Willows is served by Barry Road and Barry Road Extension. Beyond serving the needs of the local residences, this intersection can also be used by vehicles travelling between Indian Lake neighborhoods and Salisbury Street/Tatnuck Square destinations.

Barry Road, Barry Road Extension, and Toronita Avenue are all classified under Local roadway functional class. All approaches to the intersection are two-way having one travel lane in each direction. Parking is prohibited statutorily within 20 feet of the intersection. There are no crosswalks at this intersection. There are asphalt sidewalks on Barry Road and Barry Road Extension. None of which are ADA compliant. There are no curb ramps from the sidewalk on the northwest corner of the intersection. Non-compliant ramps exist on the East side of the intersection serving pedestrians crossing Toronita Ave.

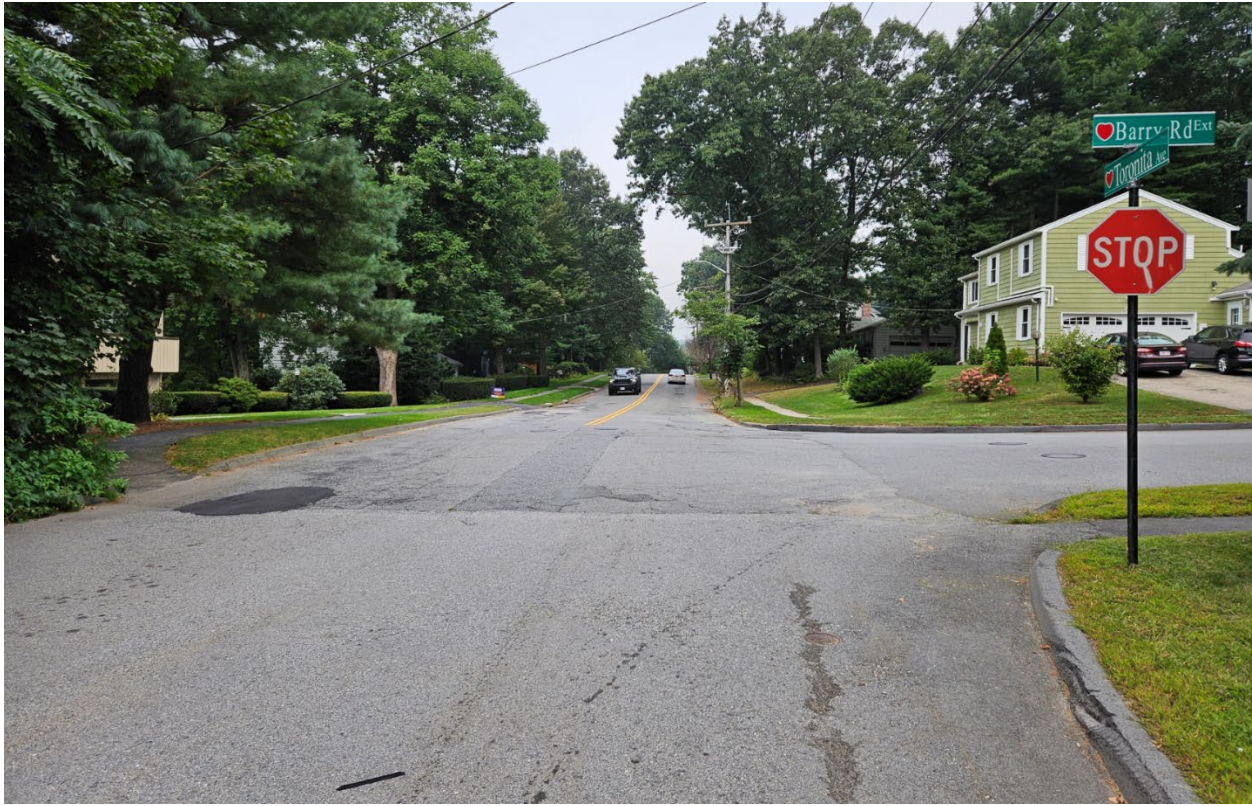
Figure 3: View westbound on Toronita Ave approaching Barry Rd and Barry Rd Ext (source: 9/8/2023 DTM site visit)

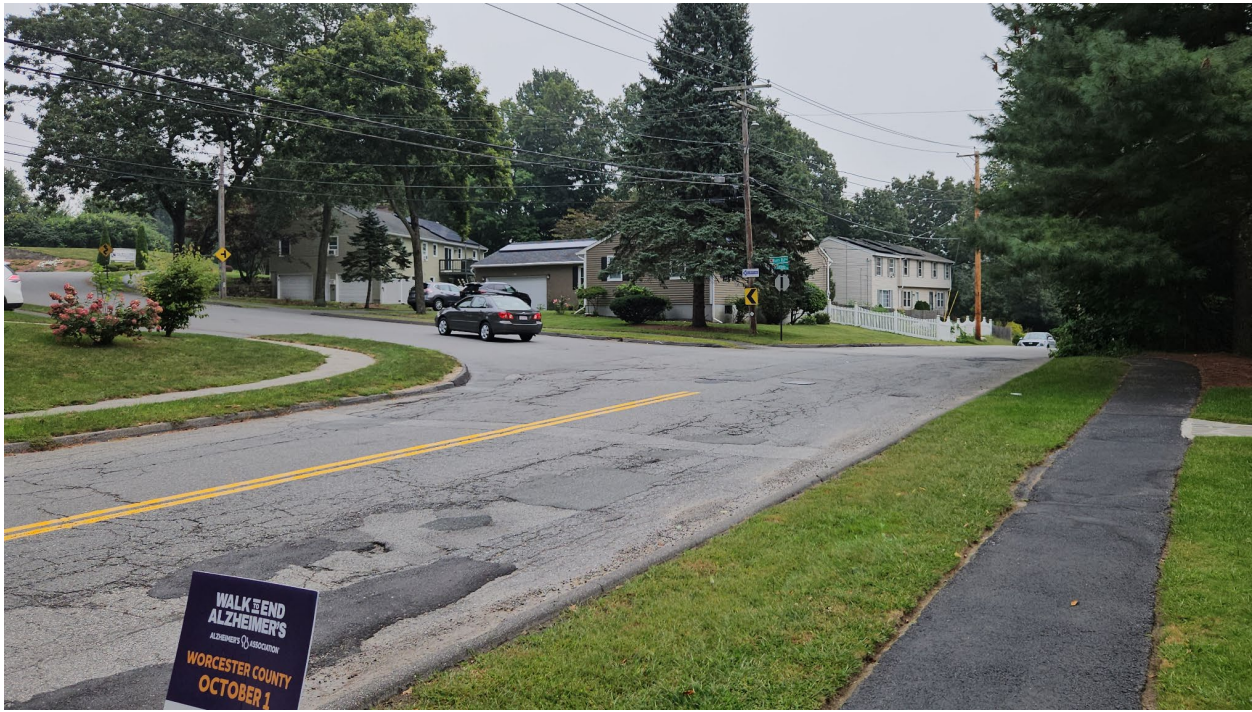
Figure 4: View eastbound on Barry Rd approaching Barry Rd Ext and Toronita Ave (source: 9/8/2023 DTM site visit)

The predominant movement at this intersection involves traffic from Barry Road making a hard, 90 degree turn onto Barry Road extension. This movement is currently uncontrolled, making it difficult for drivers on other legs to gauge whether approaching traffic is turning left or continuing straight. Further, left turning traffic has been observed commonly making the turn at a rate of speed that required encroaching into the opposing lane to negotiate the turn. Application of All Way Stop Control would effectively eliminate these two issues.

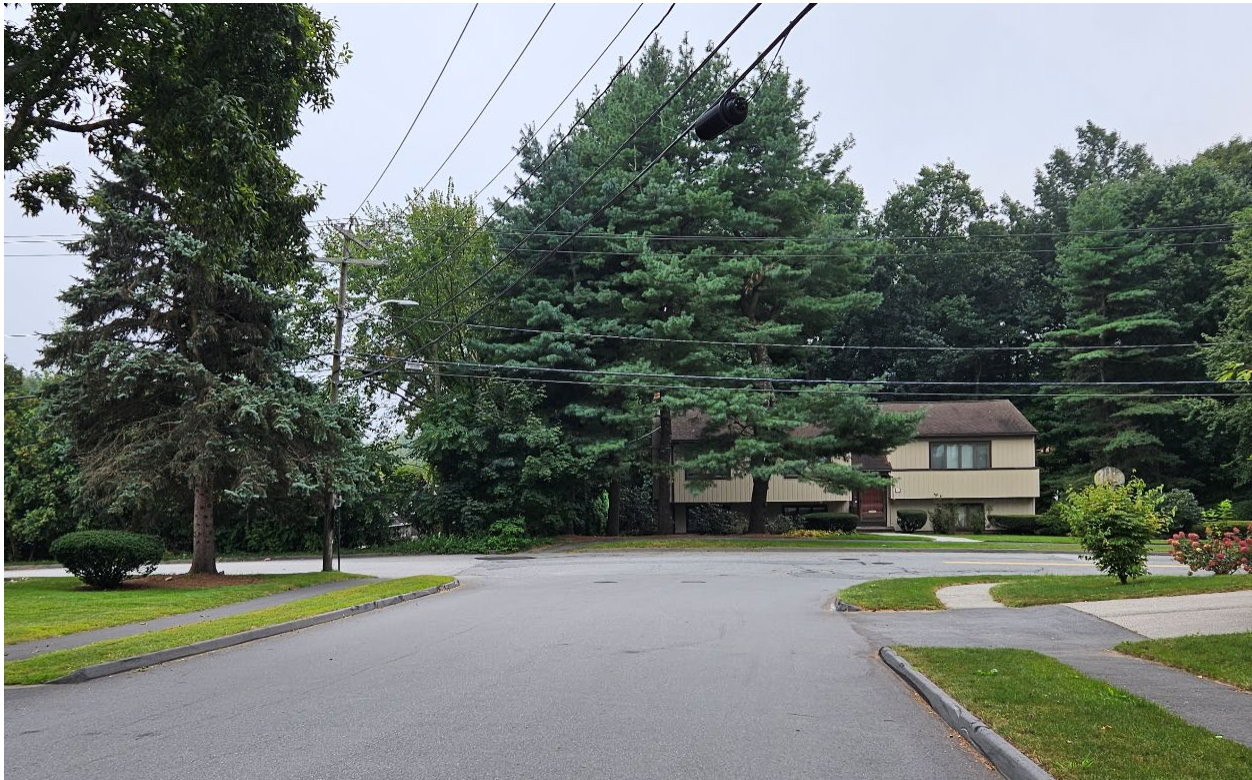
Figure 5: View southbound on Barry Rd Ext approaching Barry Rd and Toronita Ave (source: 9/8/2023 DTM site visit)
